# Potential Effects of Livestock Water-Trough Modifications on Bats in Northern Arizona

In the southwestern United States, livestock water troughs may be the only water source available to bats during dry seasons or periods of drought. We found that 38% of the 90 livestock water troughs we surveyed in northern Arizona, USA, were modified with either fencing to separate pastures or braces to strengthen the structures. We tested if these modifications could affect bat drinking behavior or increase injury risk by simultaneously videotaping modified and unmodified troughs in a series of crossover experiments performed between 1 March and 26 August 2004. The bats that we observed did not avoid modified troughs but required 3–6 times the number of passes to approach the water surface at both troughs with fences and those with support braces. The number of passes required to drink increased with reduced water surface area, suggesting that modifications of smaller troughs may have a greater effect. Small (e.g., *Myotis* spp.) and large (e.g., pallid bat [*Antrozous pallidus*]) bats responded similarly in the experiments. These effects may be energetically expensive for bats, especially du

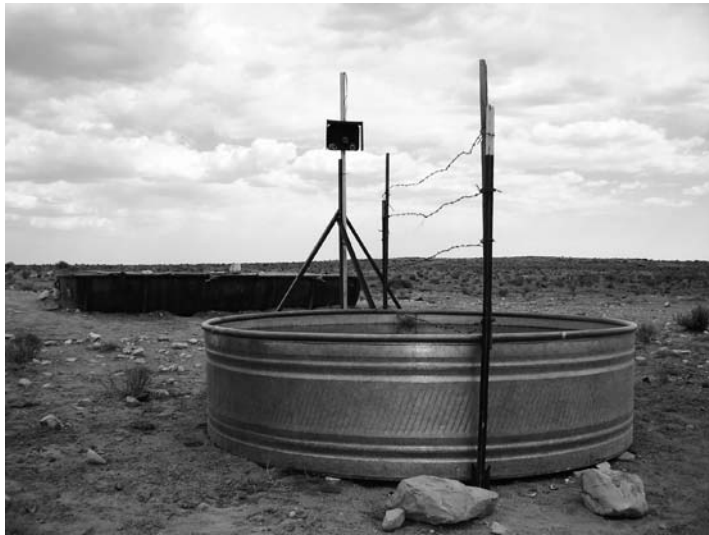
**Figure 1.** Experimental trough design at Raymond Wildlife Area, Arizona, USA, showing a modified circular and an unmodified rectangular trough (1 Jul 2004). Black and white video cameras and infrared lights are mounted on the pole between the troughs. The recording equipment is located 76 m away from the troughs.

state land and on private land when granted permission. Between 20 May and 26 August 2004, we conducted 4 experiments on the 6,070-ha Arizona Game and Fish Department's Raymond Ranch Wildlife Area approximately 60 km southeast of Flagstaff, Arizona, USA. The study site was located at 1,731-m elevation on the eastern edge of the wildlife area in Great Basin grassland (Brown 1994) consisting primarily of blue grama (*Bouteloua gracilis*), galleta (*Pleuraphis jamesii*), four-wing saltbush (*Atriplex canescens*), and snakeweed (*Gutierrezia sarothrae*). Two livestock tanks (ponds) were located 3 km from the study site and contained water until 1 June 2004. Other tanks and troughs were >6 km from the study site.

We conducted 4 experiments (3 on rectangular and 1 on circular troughs) at the Raymond Wildlife Area to determine how trough modifications affected bat use by simultaneously comparing use at an experimental (modified) trough and a control (unmodified) trough. The 2 rectangular troughs (spaced 100 m apart) had been present at the site with continuous water supply for >2 years. The water surface area of each trough was 7.5 m<sup>2</sup> compared to the mean of 4.3 m<sup>2</sup> (SE = 0.4,  $n = 38$ ) for rectangular troughs in the survey. We placed the 2 circular troughs (also spaced 100 m apart) at the site for this study. They each had a surface area of 4.7 m<sup>2</sup> compared to the mean of 10.5 m<sup>2</sup> (SE = 2.1,  $n = 52$ ) for circular troughs in the survey.
